An Analysis of MH370's Flight Path Between Waypoint IGARI and the top of the Malacca Strait, a Review of Potential Vulnerabilities Specific to Airplane 9M-MRO and a Hypothesis Regarding Possible In Flight Events and an End-of-Flight Scenario

Mick Gilbert

V3.14 27 February 2017

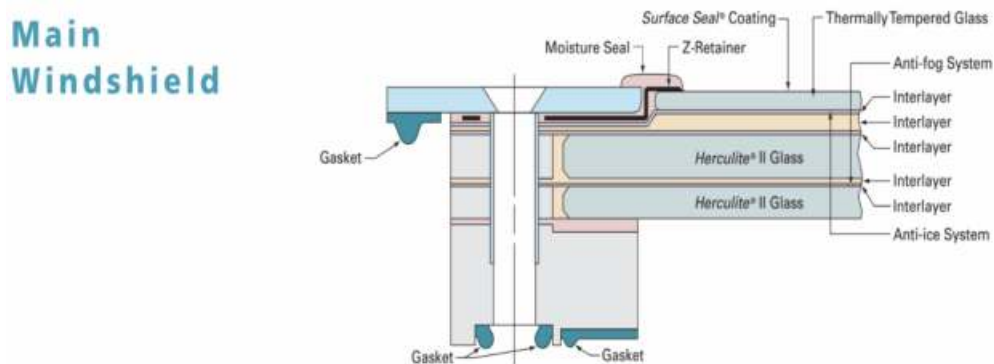
As illustrated at Figure 1, the windshield is made up of two inner panes of Herculite (chemically strengthened) glass and an outer pane of tempered glass bound together with urethane interlayers. On either side of the middle pane of Herculite and adjacent to the inner and outer panes are layers of Nesatron film. Nesatron is transparent but electrically conductive and heats up when a current is passed through it - the layers of Nesatron are the windshield heaters. The inner heater prevents fogging of the inner pane and the outer heater prevents both icing and contracting of the outer pane due to exposure to sub-zero air temperatures at altitude. If the outer pane wasn't heated it would suffer a "thermal break" and shatter which would then expose the middle pane.

Figure 1 Cross-section view of construction of B777 forward windshield

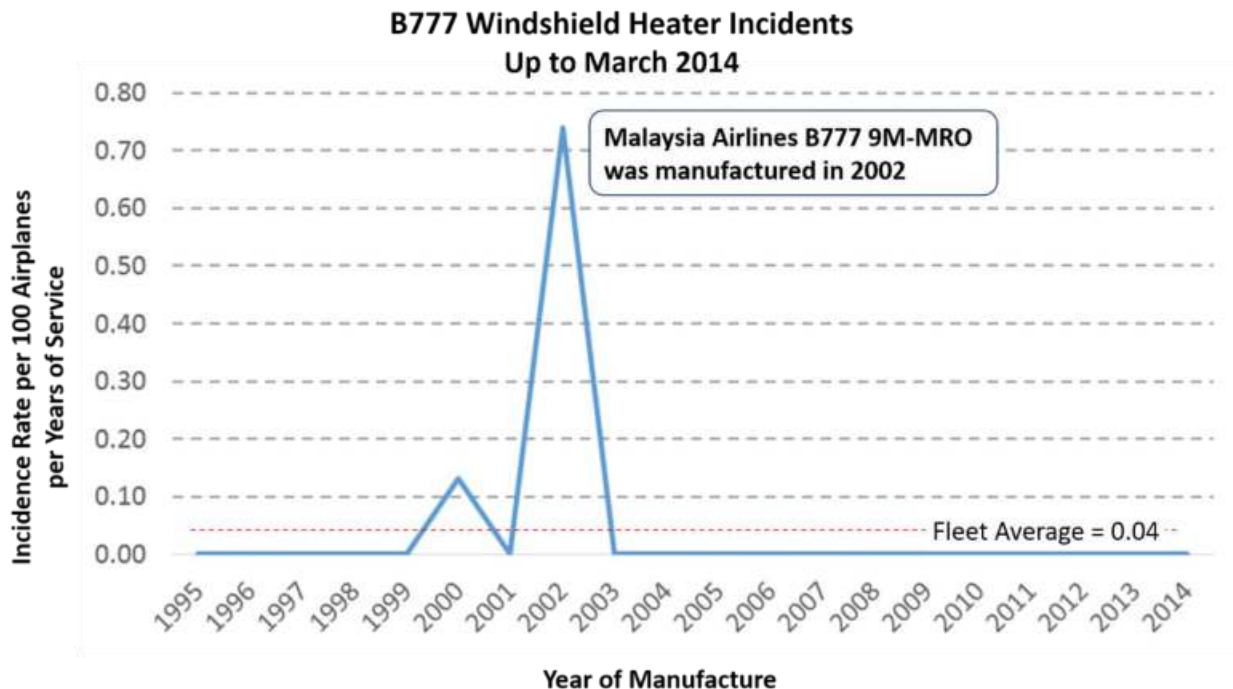
An inferential statistical analysis of the confirmed windshield heater related incidents involving B777s up to March 2014 (the time that B777 9M-MRO flew as flight MH370) highlights that 80% of the incidents occurred in less than 4% of the fleet. When adjusted for years of service, the rate of incidence of windshield heater fires/failures by years of service for B777s produced in 2002 is nearly 17 times higher than the incidence rate for the entire B777 fleet at that time and more than 100 times higher when compared to the remainder of the fleet (ie the fleet excluding the 2002 sub-group).

9M-MRO was manufactured on 14 May 2002, production line number **404**. ¹⁷

Figure 2 Incidence Rate of B777 Windshield Heater Incidents Up To March 2014 by Year of Manufacture

9M-MRO belonged to a cohort of B777s that were statistically significantly over-represented in windshield heater related incidents and it is probable that 9M-MRO's windshield heaters were inspected for condition some 4 months before it flew as MH370.

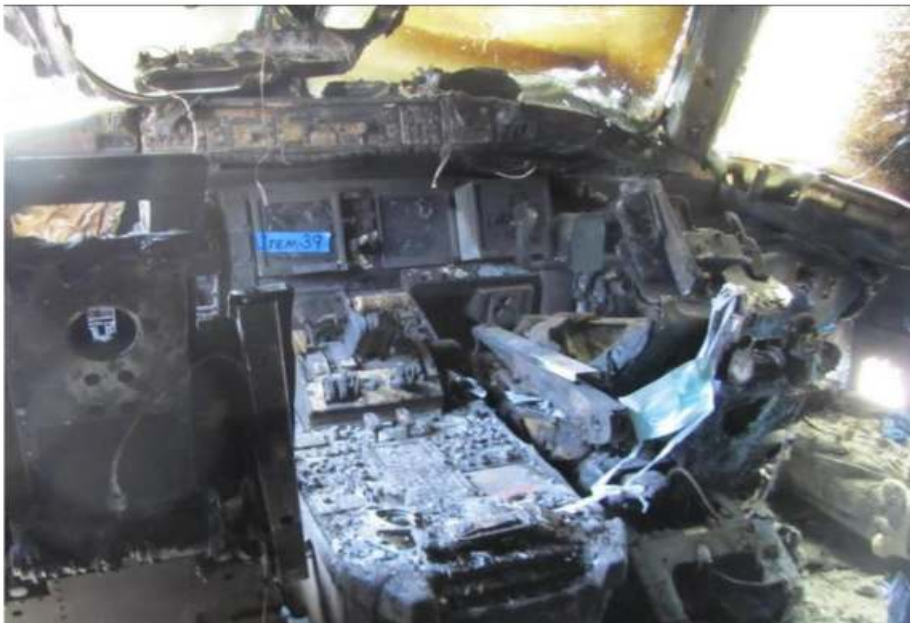
Photograph 1 *Damage to flight deck of EgyptAir B777 registration SU-GBP, at Cairo International Airport, 29 July 2011.*

Photograph 1 is of the flight deck of EgyptAir B777 registration SU-GBP that suffered an oxygen fire whilst on the ground at Cairo International Airport on 29 July 2011. ²⁸ It took less than 4 minutes for the fire to cause that damage. (As a matter of happenstance, the work that was done on 9M-MRO's crew oxygen system under FAA AD 2012-13-05 was a result of the findings and recommendations arising from the EgyptAir B777 oxygen fire.)

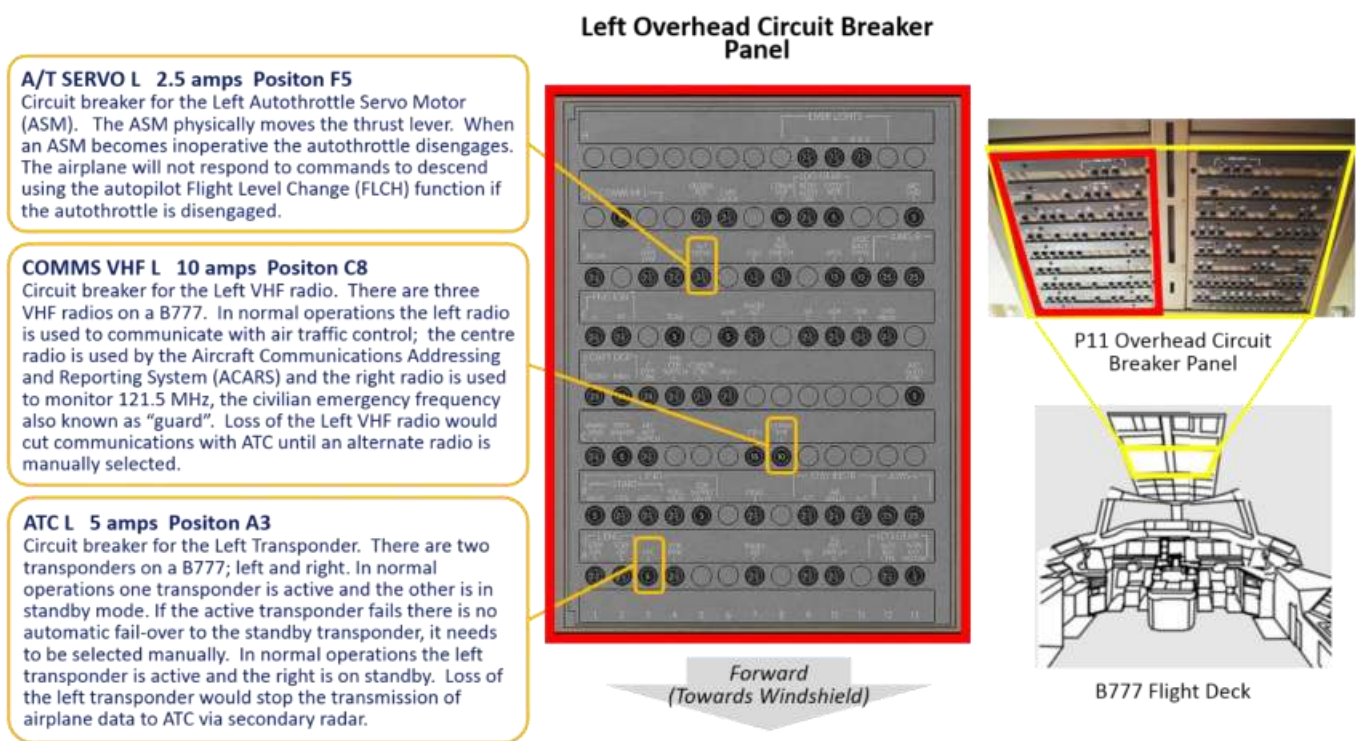
Figure 3 Key Circuit Breakers on the Left P11 Overhead Circuit Breaker Panel

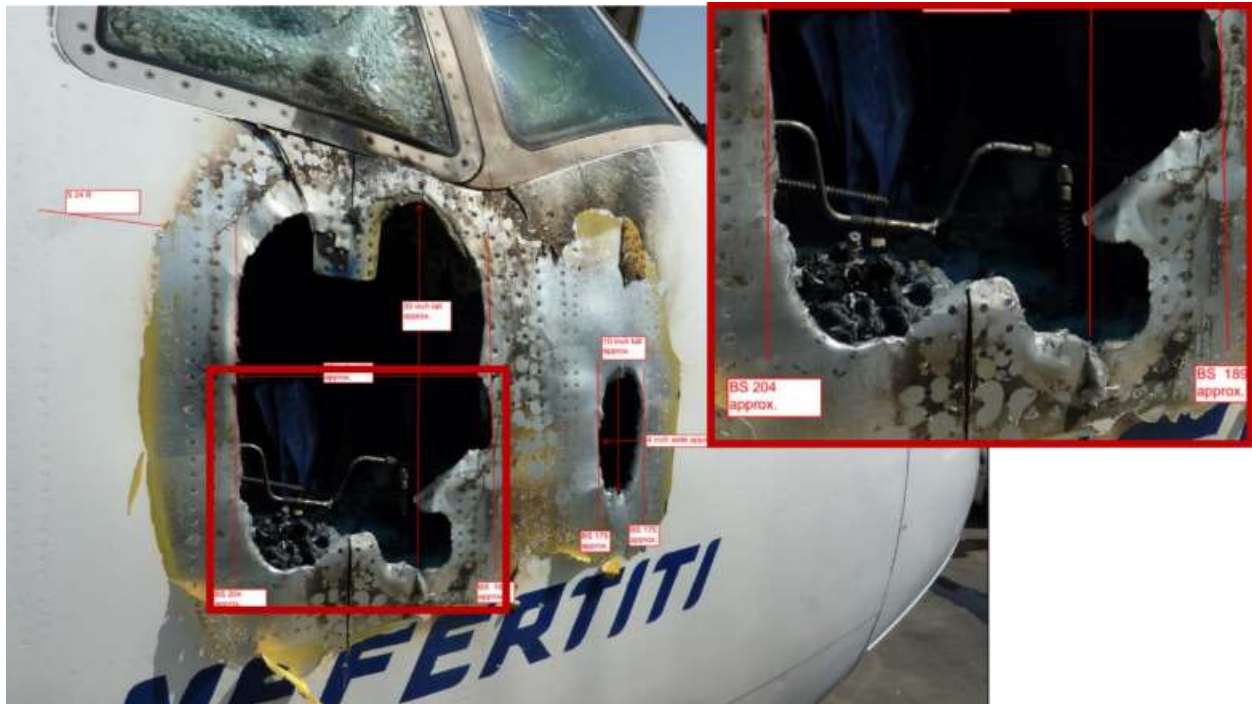
Photograph 2 shows the damage caused to the forward starboard fuselage of EgyptAir B777 registration SU-GBP that suffered an oxygen fire whilst on the ground at Cairo International Airport on 29 July 2011. It took only a few minutes for the fire to burn two holes - one 76 centimeters by 41 centimeters, the other 25 centimeters by 10 centimeters - through the fuselage adjacent to the First Officer's oxygen mask stowage box. The metal tubing visible towards the bottom of the larger hole (inset) is the stainless steel oxygen supply tubing for the crew oxygen system that carries compressed oxygen from the storage bottles in the MEC to the crew mask hoses.

Photograph 2 Damage to forward starboard fuselage of EgyptAir B777 registration SU-GBP, at Cairo International Airport, 29 July 2011.

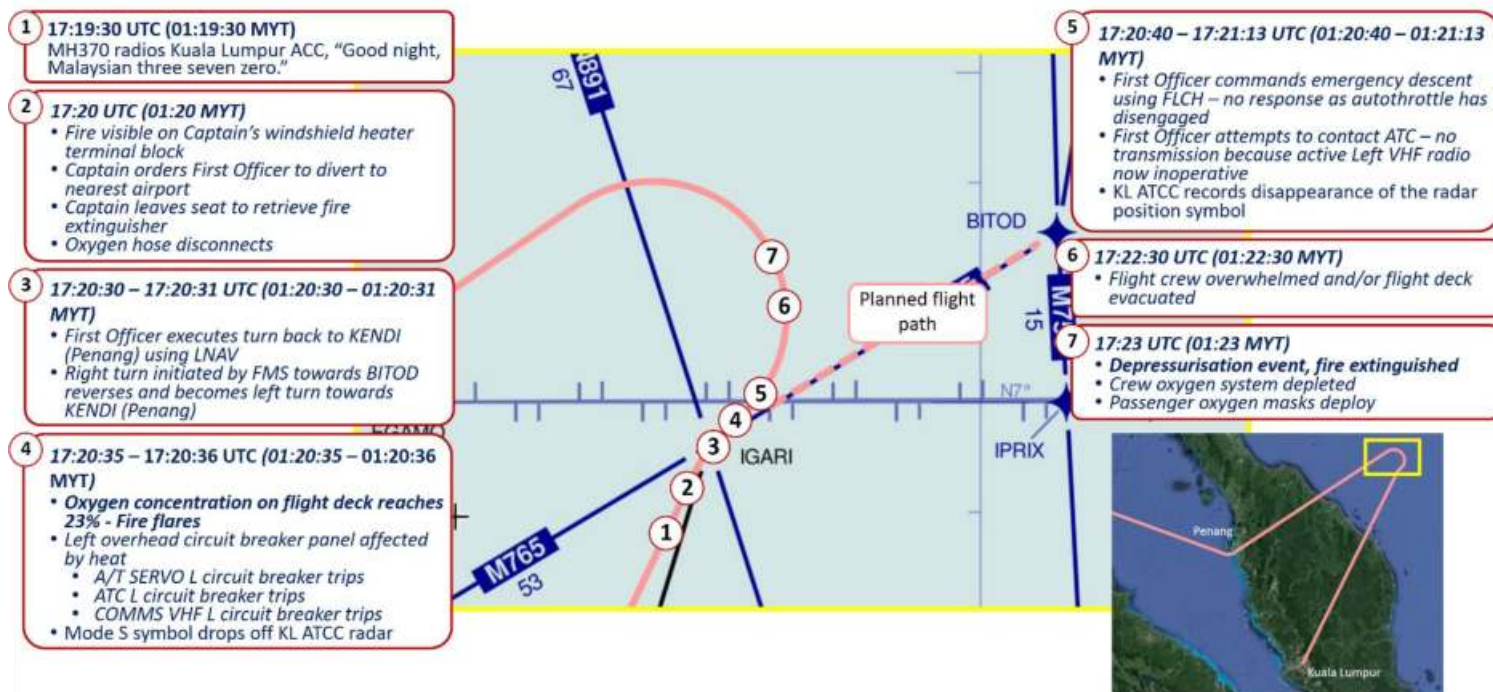
Figure 4 illustrates the sequence and timing of both observed and hypothesised events during the crucial three and half minute period from when the Captain replied to Kuala Lumpur Area Control Centre (ACC) "Good night, Malaysian Three Seven Zero" to the hypothesised depressurisation event and serves to highlight the rapid onset of events. (A more complete and detailed timeline is included at Appendix 1 MH370 – Timeline of Actual and Hypothesised Events)

Figure 4 Timeline of Actual (normal typeface) and Hypothesised (in italics) Events during the critical 3.5 minutes between 17:19:30 UTC – 17:23:00 UTC (01:19:30 MYT – 01:23:00 MYT)

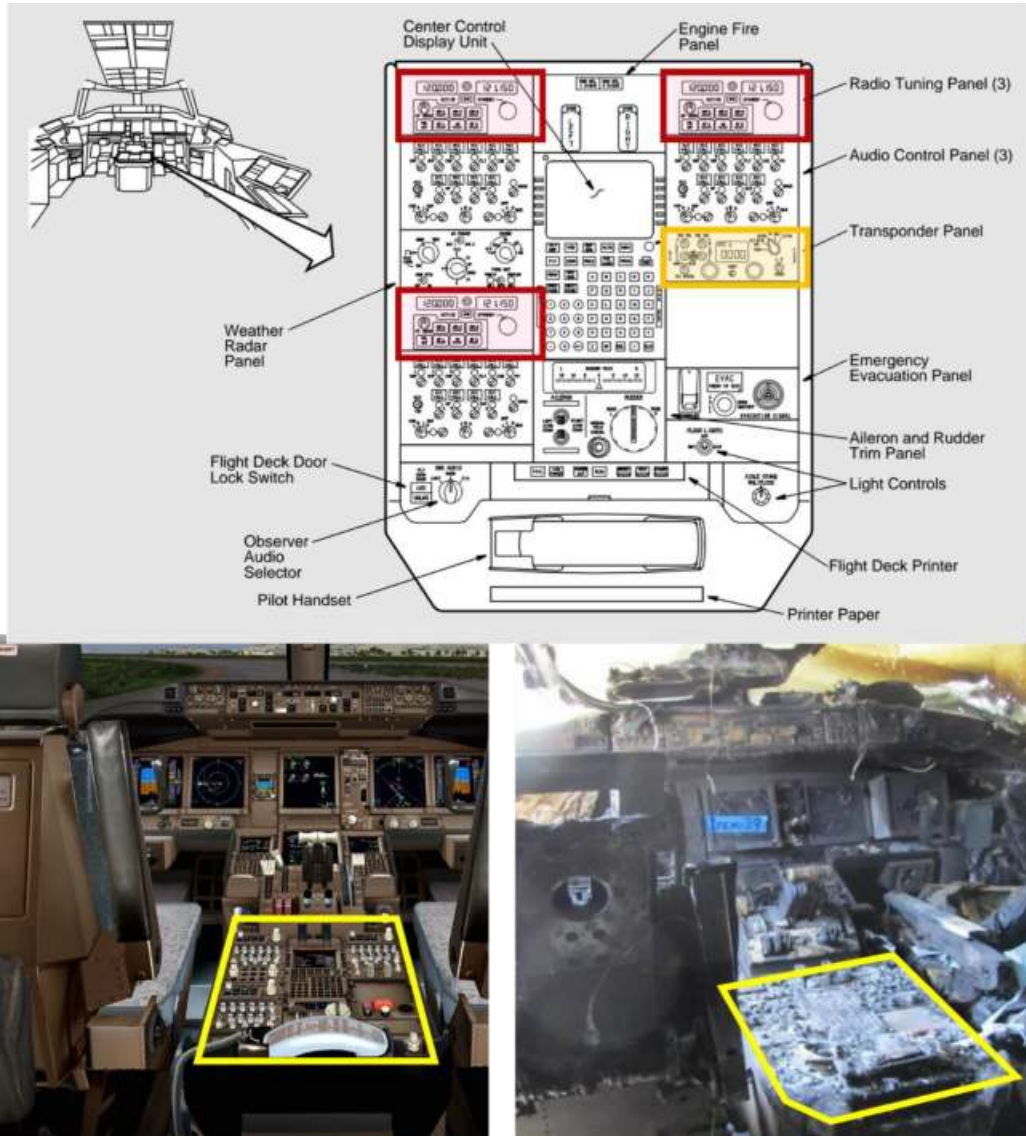
Figure 5 Location and configuration of the Aft Aisle Stand Panel (top) highlighting location of the three Radio Tuning Panels (red) and Transponder Panel (orange), together with photographs of pristine flight deck and fire damaged flight deck of EgyptAir B777 registration SU-GBP highlighting the panel (yellow).

The fire damage to the flight deck would have been something akin to EgyptAir B777 SU-GBP with the additional problems of being both noisy and cold (probably around -20°C ; the main cabin, being further removed from the source of the depressurisation, would have been less cold). The cockpit displays are liquid crystal and quite vulnerable to heat damage, in all likelihood they would have all been rendered unusable. There are no analogue back-up instruments on the B777 making instrument flying impossible. Moulded plastics such as keypads and switches together with oxygen masks and hoses, headsets and microphones would have been burned or melted.
