An Analysis of MH370's Flight Path Between Waypoint IGARI and the top of the Malacca Strait, a Review of Potential Vulnerabilities Specific to Airplane 9M-MRO and a Hypothesis Regarding Possible In Flight Events and an End-of-Flight Scenario

Mick Gilbert

V3.14 27 February 2017

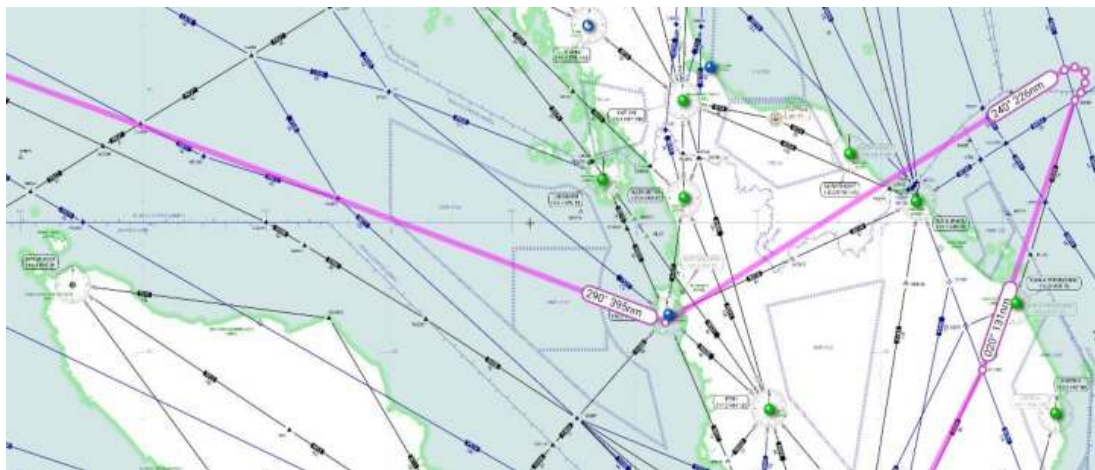
Map 1 Probable flight path of MH370 south-west over the Malay Peninsula and north-west up the Malacca Strait.

Map 1 illustrates the very simple course that MH370 flew; an initial right turn at IGARI towards BITOD followed almost immediately by a left turn back towards Penang on a heading of 240°. Then from south of Penang a right turn to 290°; this track would take MH370 over VAMPI and to the north of MEKAR.

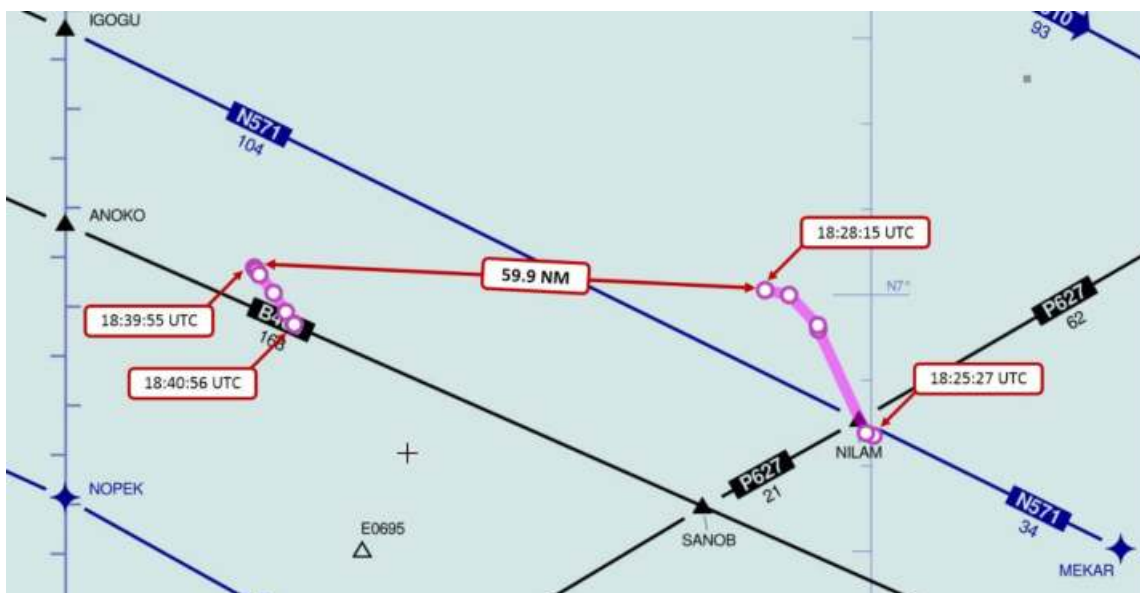
Based on the time intervals and distance travelled, the ground speeds calculated for the airplane are 421 knots for the first section and 415 knots for the second section. Accordingly, it would not be unreasonable to infer that the airplane was flying at a relatively constant speed.

That being the case, the 59.9 nautical mile gap between the two segments presents a problem. For the airplane to have taken 11 minutes 40 seconds to traverse the gap directly it would have had to fly at an improbably slow 308 knots.

Map 2 MH370's positions between 18:25:27 - 18:28:14 UTC (02:25:27 - 02:28:14 MYT) and between 18:39:55 - 18:40:56 UTC (02:39:55 - 02:40:56 MYT)

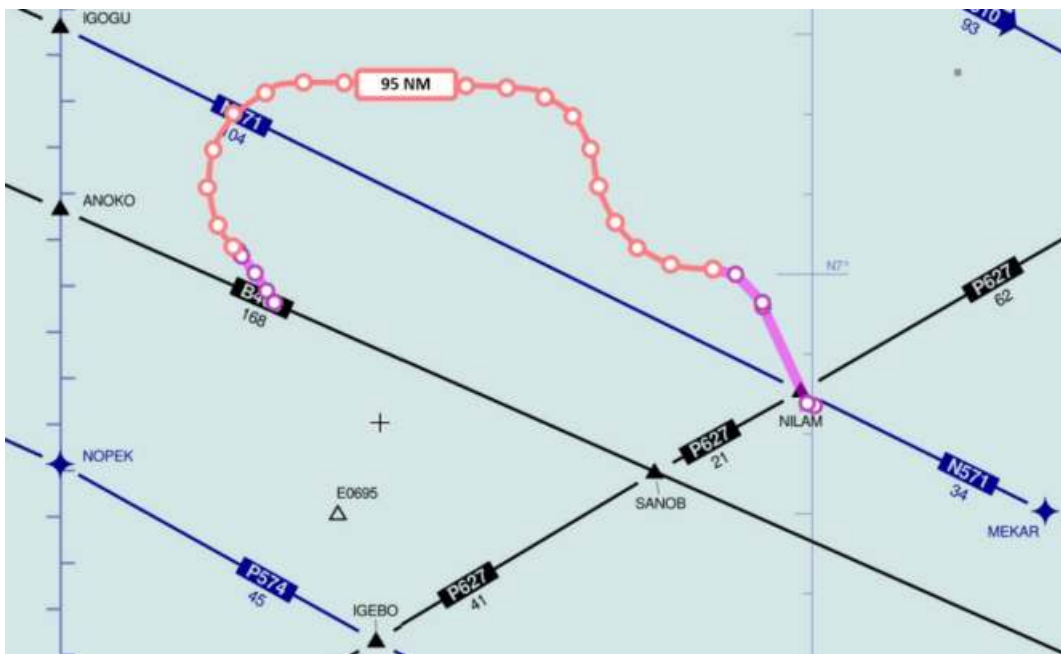
This track consists of a 90° turn to starboard followed by a 90° turn to port, tracking along a heading of roughly 280° for some 25 nautical miles followed by a 90° turn back to port and ending with a further 45° turn to port. All turns have a radius of about 12.8 nautical miles - the turning radius of a Boeing B777 at cruising speed with bank limited to 15° in nil wind. The total distance flown is about 95 nautical miles giving an average ground speed of 426 knots, which is broadly consistent with the entry and exit speeds.

Map 3 Possible solution for transiting the gap using standard 15° bank limited turns

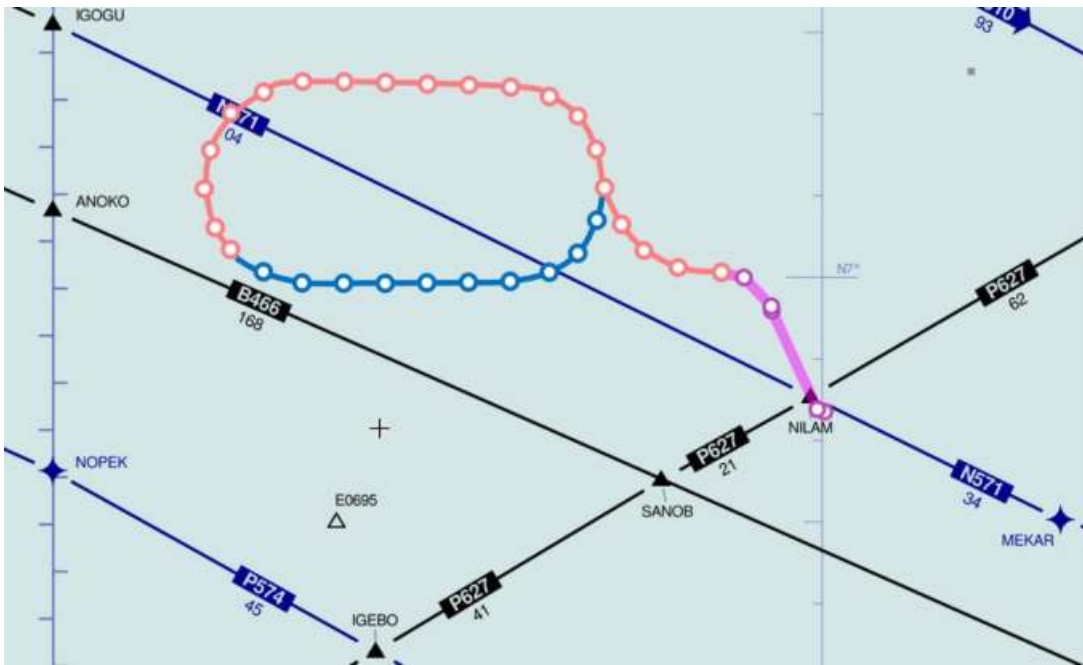
The hypothesised track is the first half of a standard racetrack pattern, as illustrated at Map 4. The track could be flown using the MCP autopilot in Heading Select (HDG SEL) or Track Select (TRK SEL) mode using no instruments (roll out to wings level would indicate that the airplane had settled on the selected heading) except for a watch or time piece. A watch is required to time the straight legs of the pattern.

The pattern was entered by flying North 000° off the track away from Penang then West 270° and then North 000°. The holding pattern itself may well have been a simple, symmetrical series of 2.5 minute manoeuvres; two 90° turns in one direction (eg North 000° then West 270°) each taking 2.5 minutes to complete, followed by a 2.5 minute straight leg followed by two 90° turns in the opposite direction (eg South 180° then East 090°) followed by another 2.5 minute straight leg giving a 15 minute repeatable pattern. The pattern can be flown using the autopilot MCP HDG SEL or TRK SEL function and a watch..

Map 4 The complete hypothesised Racetrack loiter manoeuvre

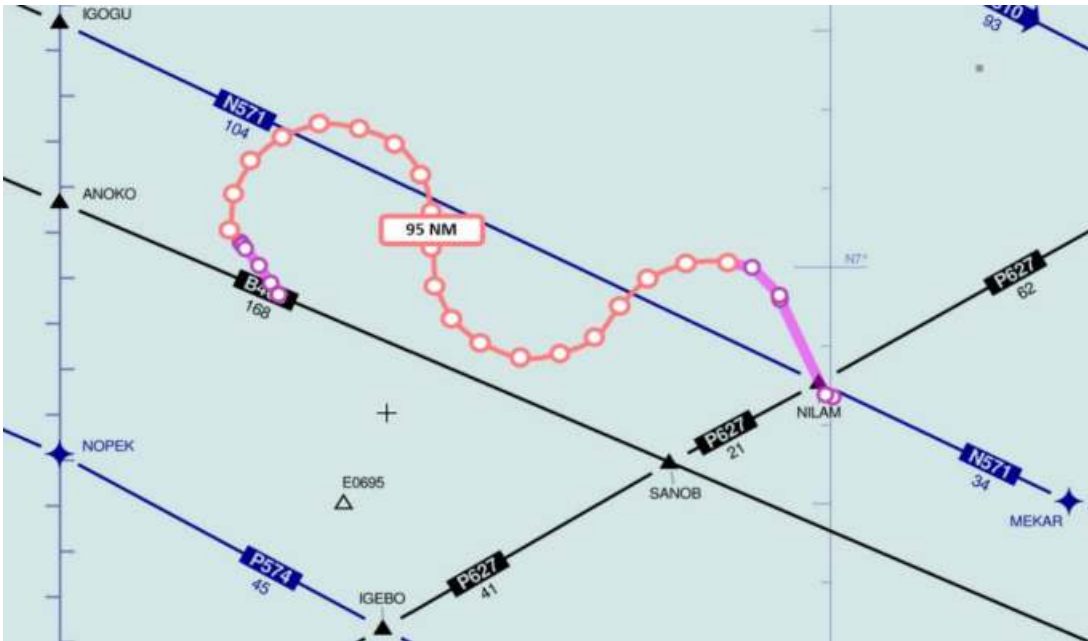
Map 5 Alternative possible solution for transiting the gap using standard 15° bank limited turns

The track consists of a 45° turn to port followed by a 90° turn to starboard followed by a 180° turn back to port. All turns have a radius of about 12.8 nautical miles. The total distance flown is again about 95 nautical miles giving an average ground speed of 426 knots, which is again broadly consistent with the entry and exit speeds.

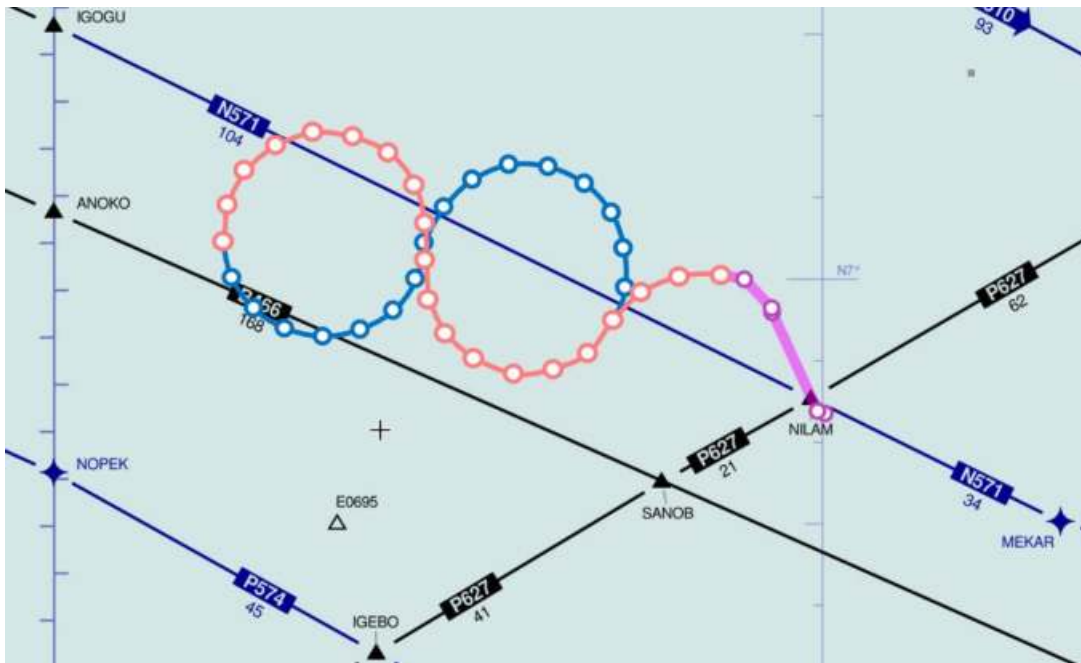
The hypothesised track represents the first half of a Figure 8 manoeuvre, as illustrated below.

Map 6 The complete hypothesised Figure 8 loiter manoeuvre

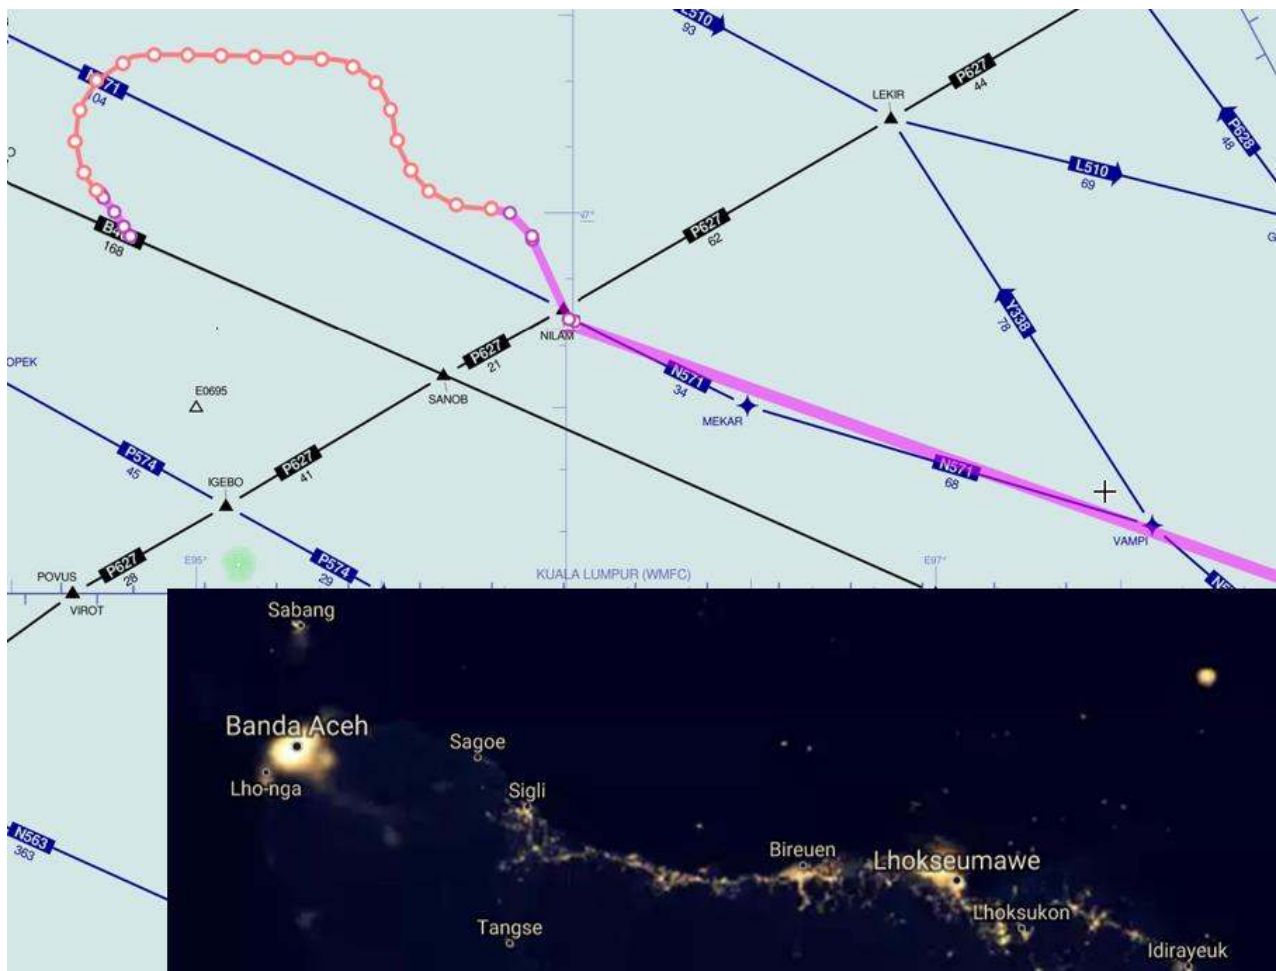
There is no compelling evidence that the airplane was being navigated in any sophisticated fashion and it was not tracking via waypoints. When the SATCOM log-on process first started Banda Aceh would have been clearly visible at about 7° forward of abeam. The map below, with the Indonesian coastline at night overlaid, shows the points at which the manoeuvre commenced and completed with reference to Banda Aceh.

Map 7 The location of the hypothesised loiter manoeuvre showing its relationship to Banda Aceh (shown as visible at night).

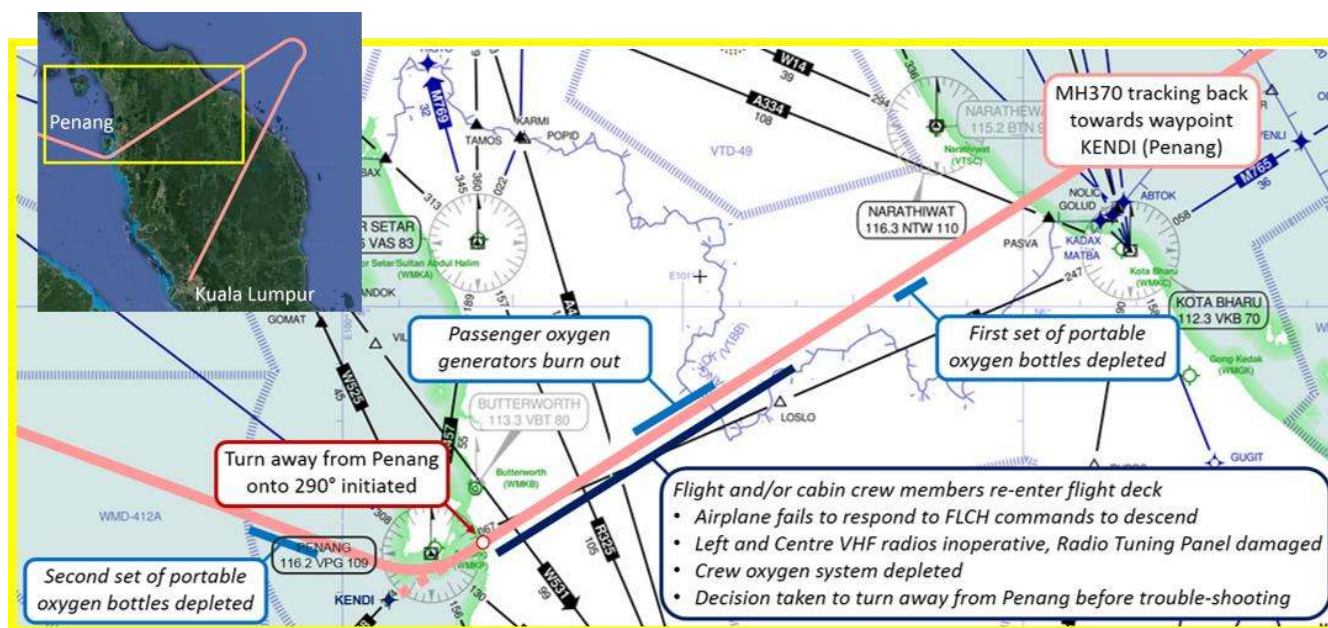
Figure 6 The transit of the Malay Peninsula and the turn-away from Penang

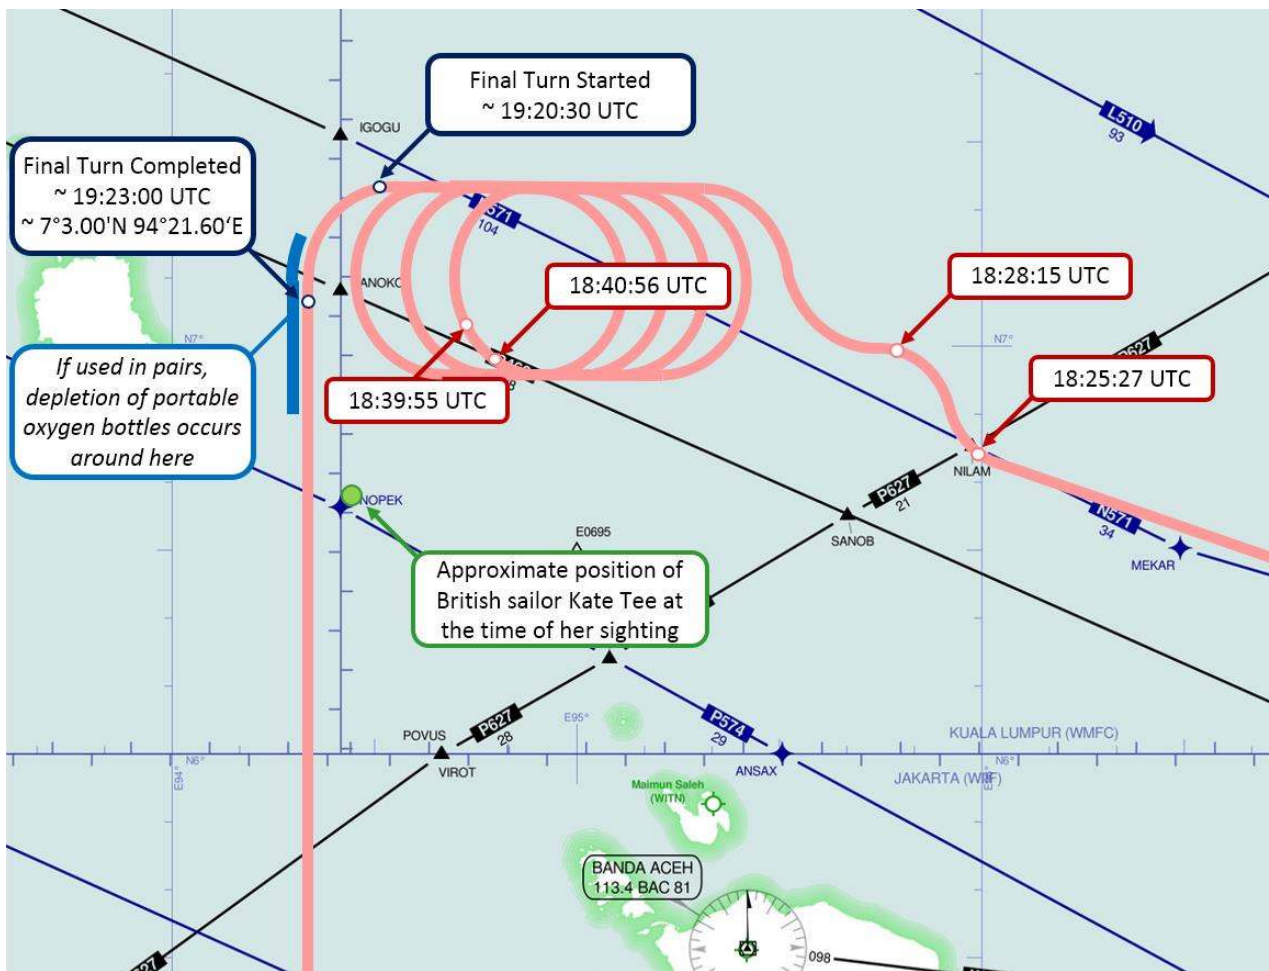
Map 8 Hypothesised manoeuvres at the top of the Malacca Strait showing westerly drift and a final turn south onto a track of 180° near 7°3.00' N 94°21.60' E at around 19:23:00 UTC (03:20:00 MYT).

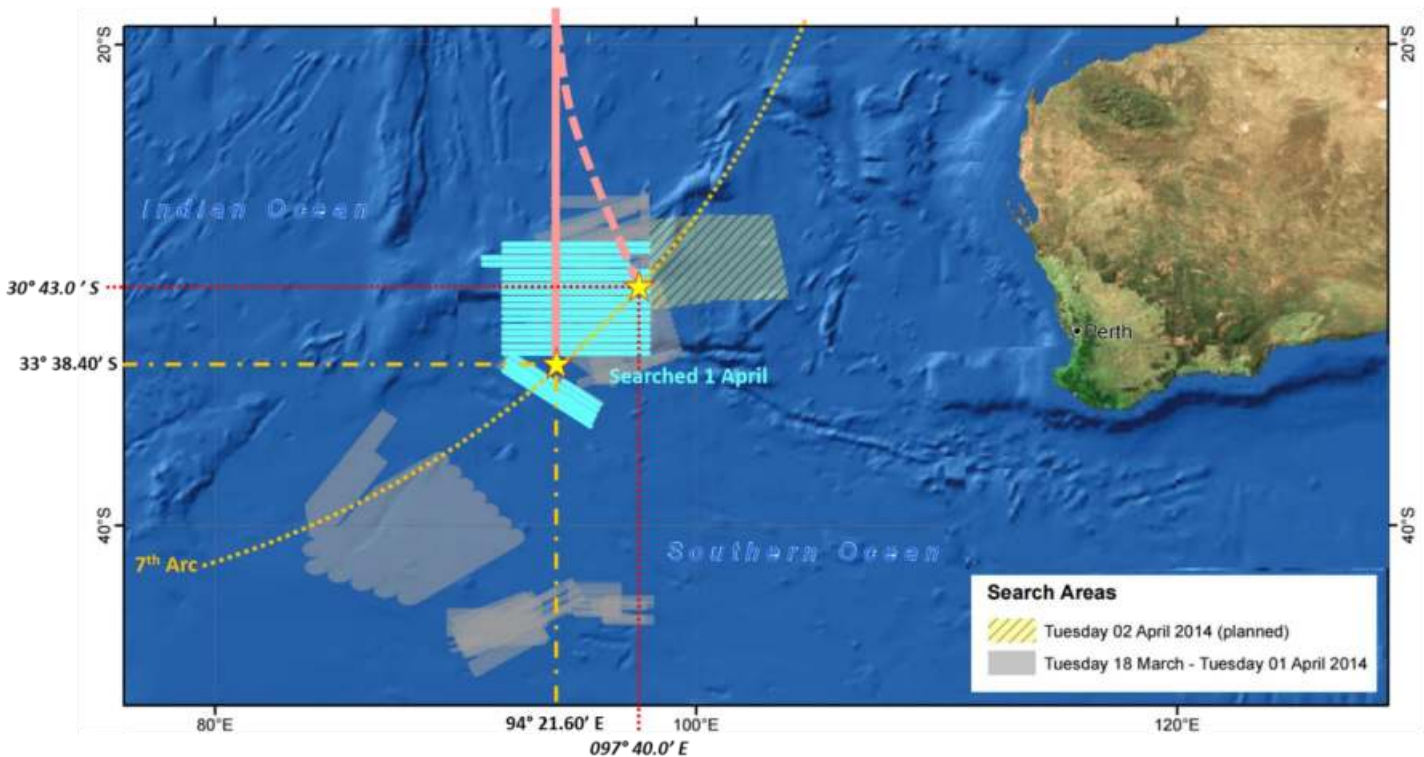
Map 9 Probable impact areas based on final turn south (180°) at the top of the Malacca Strait from near 7°3.00' N 94°21.60' E at around 19:23:00 UTC (03:20:00 MYT) using Track Select (solid path) and Heading Select (dashed path).

TRK SEL yields a straight flight path south that terminates on the 7th arc near 33°38.40' S 94°21.60' E. On the other hand, HDG SEL gives rise to a flight path that curves away to the east under the influence of the prevailing westerly winds and terminates with fuel exhaustion beyond the 7th arc. However, I have plotted the intersection of the flight path with the 7th arc to be near 30°43' S 097°40' E. The two possible impact sites are nearly 480 kilometers apart.

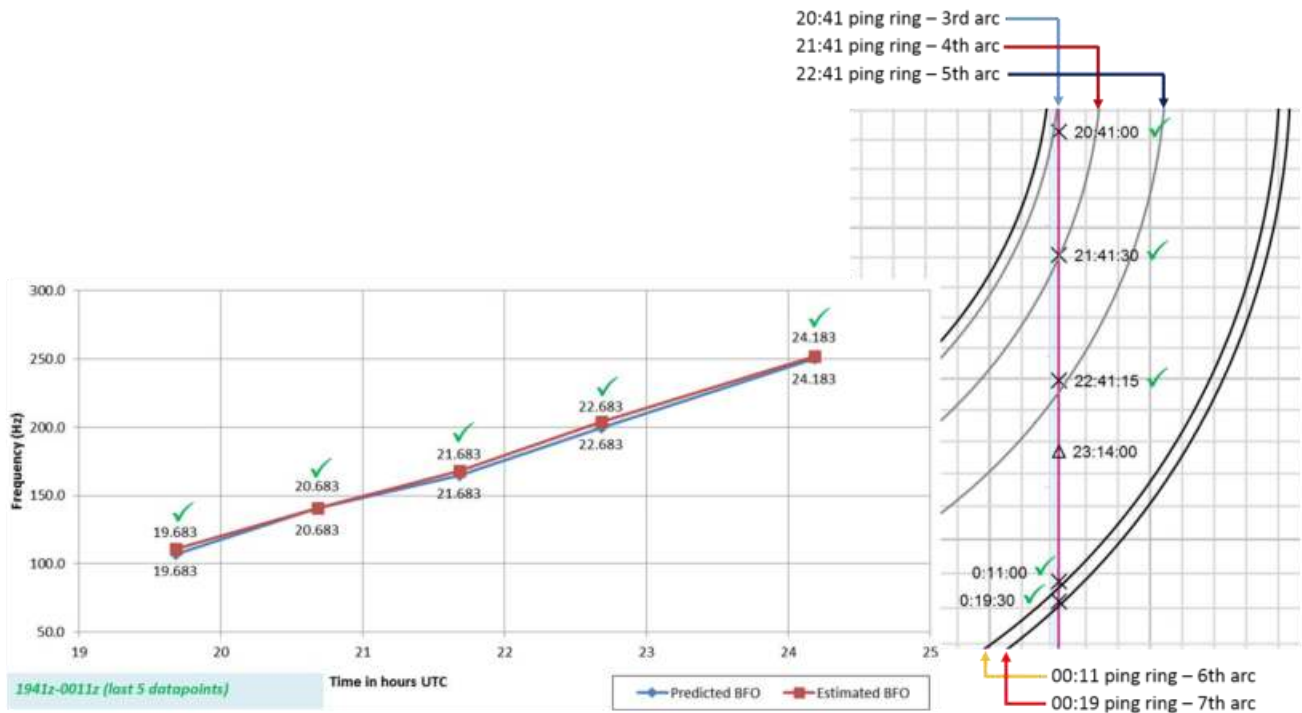
As illustrated at Figures 7 and 8, when the two flight paths are modelled against the actual BTO and BFO readings using Barry Martin's (Independent Group) BSM7.9.4 flight path model⁴⁷ (Barry has pointed out that this somewhat older model contains some minor errors with regards to magnetic declination) TRK SEL produces an extraordinarily good fit to both BTO and BFO, far better than the results for the more commonly used HDG SEL. Based on the modelling I tend to prefer 33°38.40' S 94°21.60' E as the more likely crash site but I cannot discount 30°43' S 097°40' E on the basis that HDG SEL is the more commonly used MCP mode. I expect that the sunken wreckage of MH370 will be found within 50 kilometers of either of those two locations – a search area of some 15,750 square kilometers.

Figure 7 Modelled BTO and BFO outcomes for final southern leg using TRK SEL showing very good fits to both BFO and BTO data

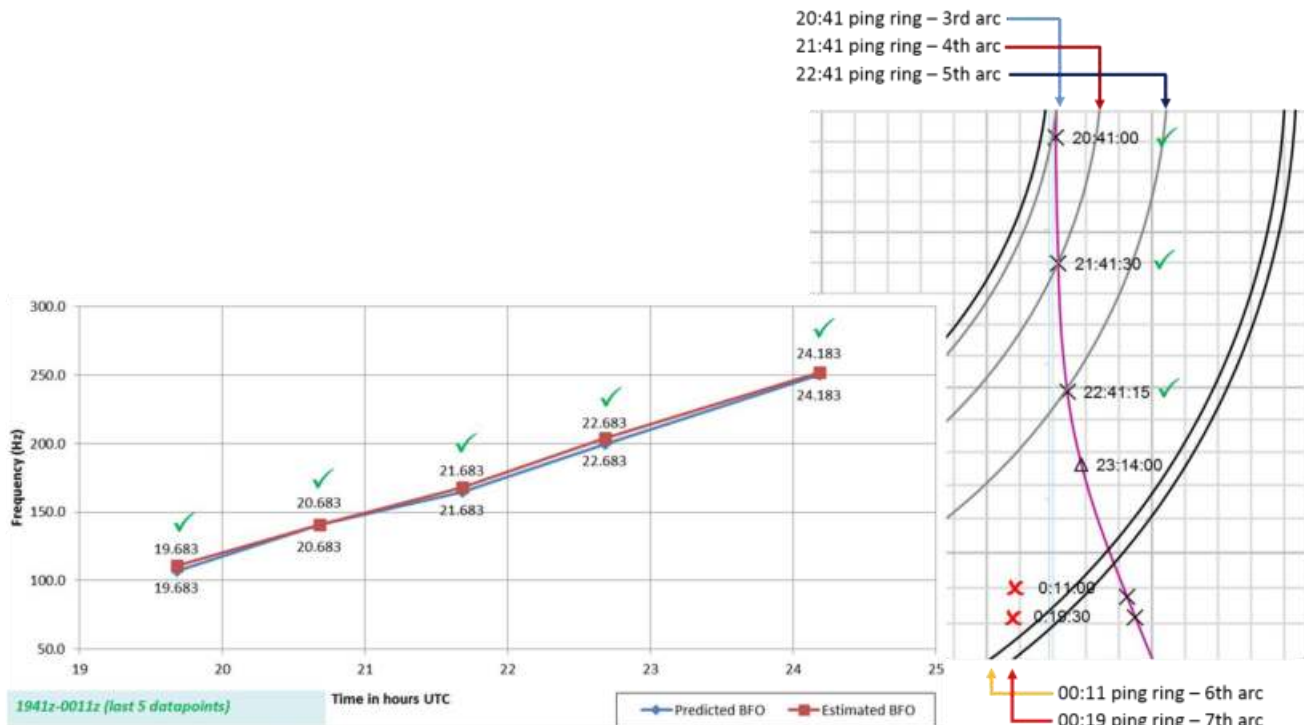
Figure 8 Modelled BTO and BFO outcomes for final southern leg using HDG SEL showing very good fit to BFO but less good fit to BTO data

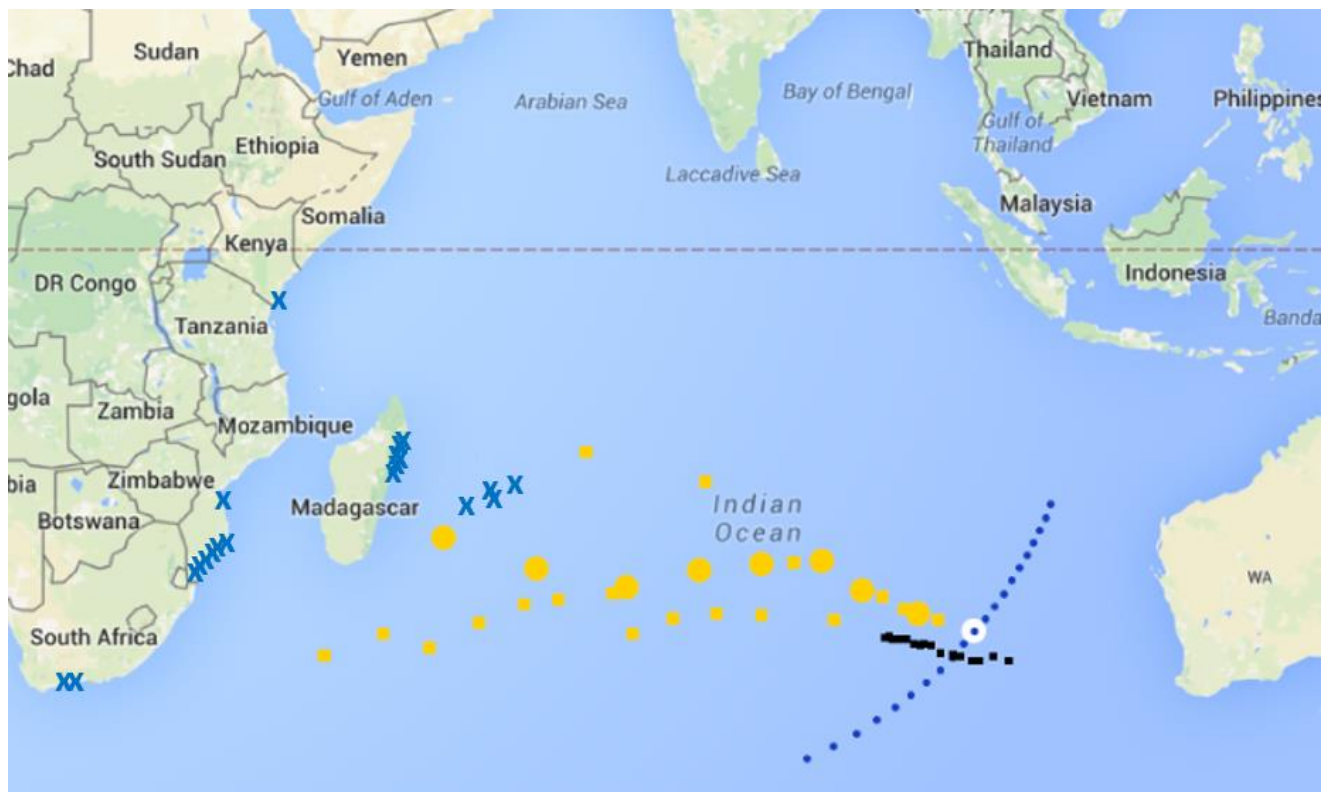
Importantly, Richard's analysis and modelling "... appears to support a probable end point of MH370 around 30°S near the 7th Arc." Accordingly, drift modelling is broadly supportive of the HDG SEL impact point at 30°43' S 097°40' E and it does not exclude the TRK SEL impact point, 33°38.40' S 94°21.60' E.

Map 10 Drift modelling from an Impact on the 7th arc at latitude 30°S .

Crosses mark the location of wreckage finds. The circles show the simulated path of floating debris by month; the colour of the circles indicates sea water temperatures; below 19°C are shown in white and between 19°C and 25°C are shown in orange. The 7th Arc is marked with dark blue dots and the undersea feature known as Broken Ridge is marked with black squares.
